# **Pentium<sup>®</sup> II Processor Specification Update**

Release Date: December 1997

Order Number: 243337-008

The Pentium<sup>®</sup> II processor may contain design defects or errors known as errata which may cause the product to deviate from published specifications. Current characterized errata are documented in this Specification Update.

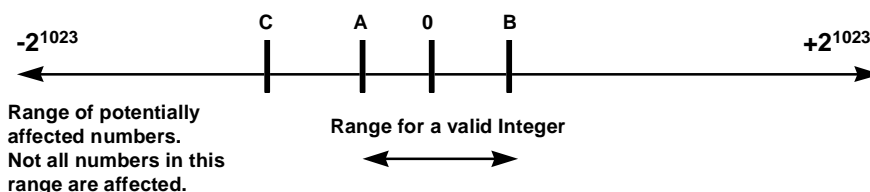
**IMPLICATION:** Erroneous operation results when the operand is so large that it will not fit into the target data size. The operands affected by this erratum are significantly outside (by a factor of 3X) the range that can be, correctly, converted to an integer value. The figure below and corresponding table identifies the normal range of integer numbers (between A and B) and the starting point of the operands affected by this erratum. Discrete failing operands will be present in the range between point C and the maximum negative number that can be represented by the processor ( $-2^{1023}$  in double precision format). Note 2 below gives a qualitative description of the nature of the discrete failing values. Software that does not rely on the Invalid Operation exception flag being set and signaled by either an exception OR by software polling is not impacted by this erratum.

16-bit Operation	A	B	C
	-32,768.0	+32,767.0	< -98304.0
32-bit Operation	A	B	C
	-2,147,483,648.0	+2,147,483,647.0	< -6,442,450,944.0

**WORKAROUND:** Any of two software workarounds will avoid occurrence of this erratum:

1. Range checking performed prior to execution of the FIST[P] instruction will prevent the overflow condition from occurring, and may already be implemented as a standard coding style.
2. Software can use the presence of MAXNEG in the result integer to indicate that an out of range conversion may have occurred.
